Technical Service Bulletin

Torsion Axles: Arm/Axle Cord Creep

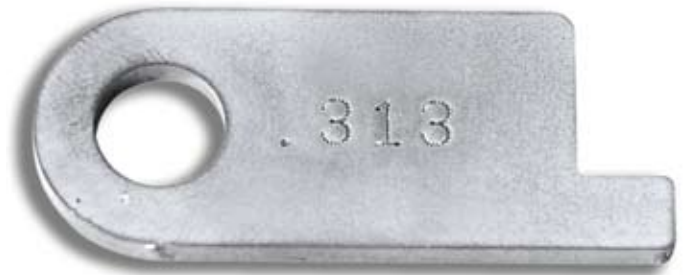
Tie Down Engineering has developed a simple measuring tool to use on Eliminator brand torsion axles for the purpose of determining if the axle has any cord creep. Torsion axles by in large have very few issues to deal with, however in certain situations, generally with multi axle trailers, cord creep can occur. This can be caused by accidents, severe impact on curbs and potholes or tight turns in sand and dirt where the twisting of the trailer pulls sideways on the axles.

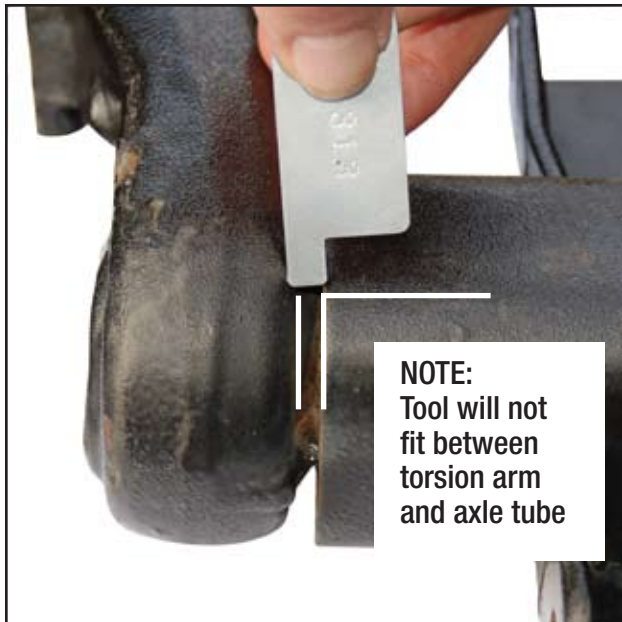
Acceptable

Inner cords showing at the torsion arm are not an indication of cord creep. To easily determine if there is cord creep, use this gauge by inserting the narrow extension between the axle tube and torsion arm. If the gauge can be fully inserted touching a flat side of the inner bar with the tip of the extension, the axle can be identified as beginning cord creep. If the gauge is stopped at any point by the axle tube or torsion arm, the axle is within design specifications.

NOTE:
Tool will not
fit between
torsion arm
and axle tube
