Tire Warranty Conditions

COVERED Warranty Conditions	NOT COVERED Warranty Conditions
<p>TREAD:</p> <ul style="list-style-type: none"> • Tread Separation <p>SIDEWALL:</p> <ul style="list-style-type: none"> • Shoulder Cracking • Sidewall Separation • Spread Ply <p>BEAD:</p> <ul style="list-style-type: none"> • Circumferential Bead Cracking • Migrating Bead Wire • Bead Area Separation <p>LINER:</p> <ul style="list-style-type: none"> • Trapped Air in Liner over 0.25 inch • Liner Crack • Thin Liner • Open Liner Splice <p>OTHER:</p> <ul style="list-style-type: none"> • Light/thin Rubber • Foreign Material • Vibration before the first 2/32nd of treadwear • Weather Checking (2 years from date of purchase) 	<p>ROAD HAZARDS:</p> <ul style="list-style-type: none"> • Sidewall Cut • Curbing (Sidewall or Shoulder) • Bubble in Sidewall • Puncture Beyond Repairable Limits • Impact Break in Liner • Impact Break Across Tread • Cut Tread • Ran Underinflated to Destruction <p>IRREGULAR WEAR:</p> <ul style="list-style-type: none"> • Heel and Toe Wear • Diagonal Wipe Wear • Depressed Rib Wear • Erosion Wear • Fast Centerline Wear • 360* One-Side Shoulder Wear • 360* Both Side Shoulder Wear • Hi-low Lug

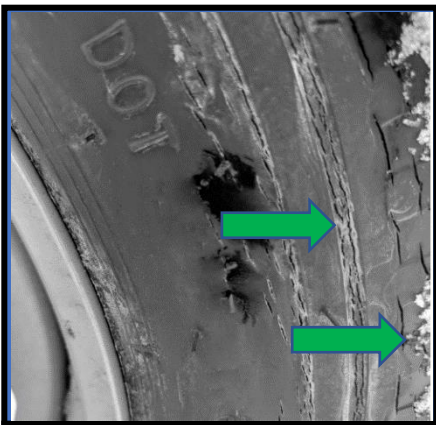
Shoulder Cracking

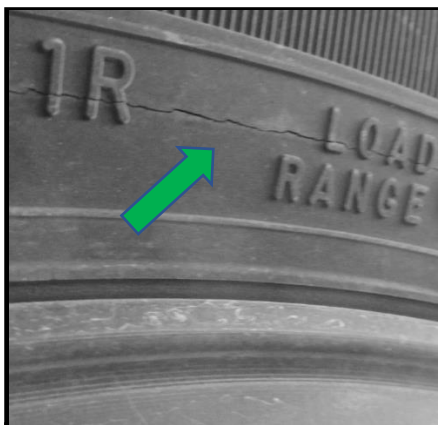
Circumferential Bead Cracking

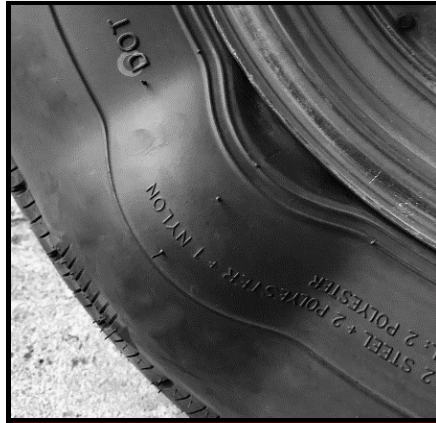
Impact Break - Sidewall

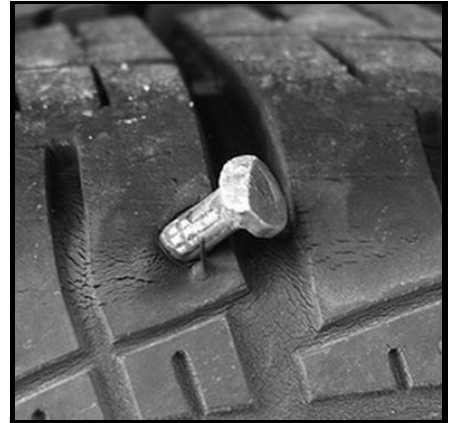
Puncture Beyond Repair

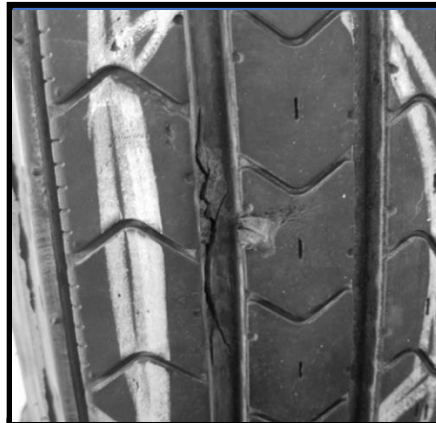
Cut Sidewall or Tread

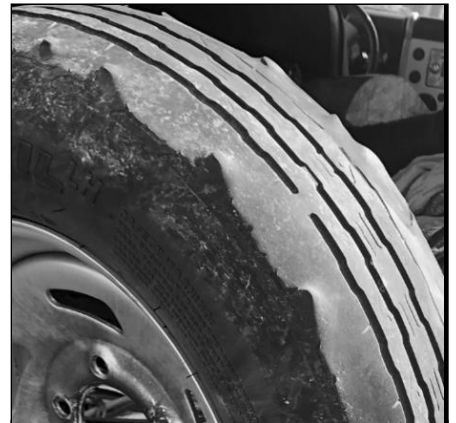
Irregular Wear

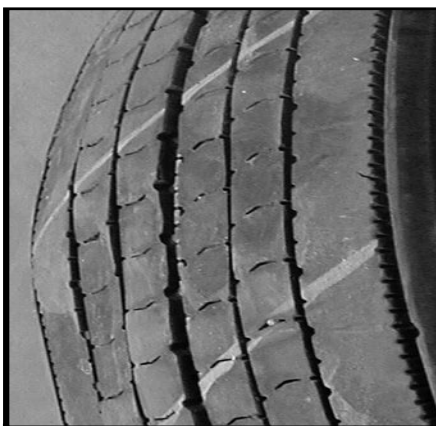
Diagonal Wipe

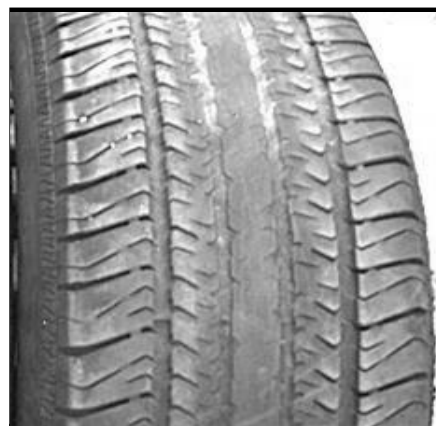
Fast Centerline Wear

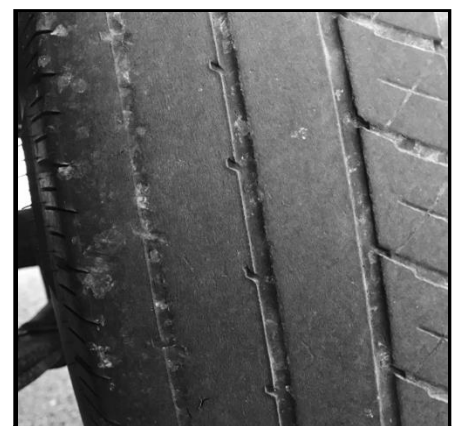
Fast Shoulder Wear

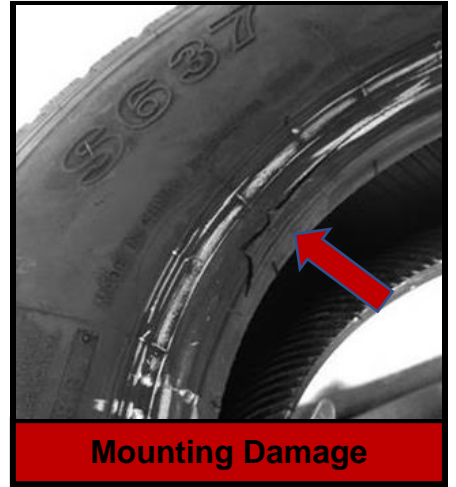
Mounting Damage

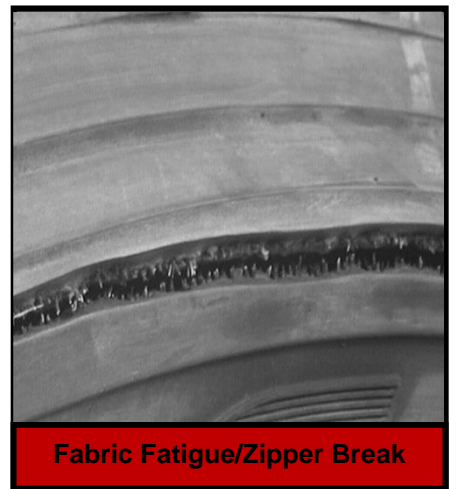
Fabric Fatigue/Zipper Break

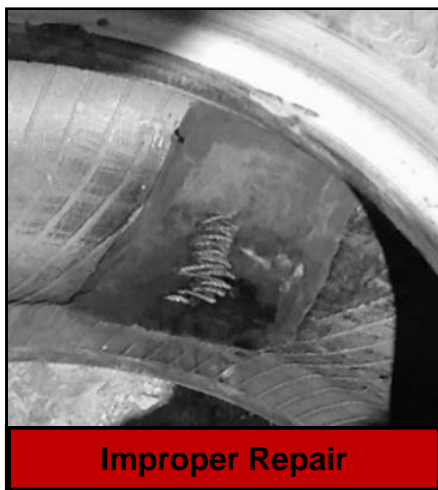
Improper Repair

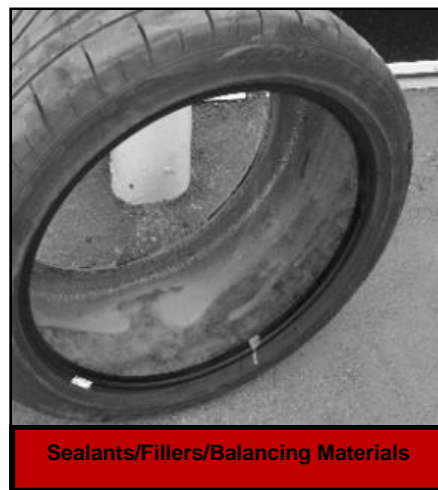
Sealants/Fillers/Balancing Materials

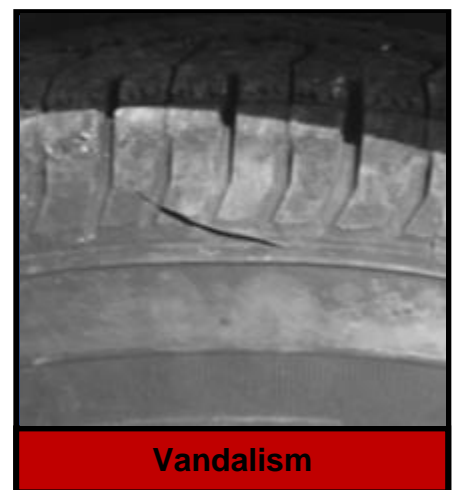
Vandalism
